Sunnyside Home Inspections

Property Inspection Report

123 Example St, Denver, CO 80212
Inspection prepared for: Client Example
Date of Inspection: 1/9/2021

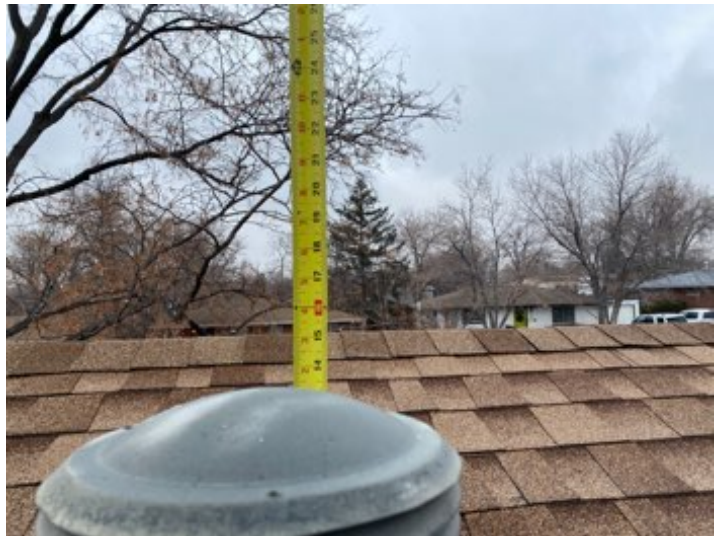
- Flue stack was too low
- Storm collar not installed
- **Caulk/Sealant is recommended**

Flue vent was observed to be well below the 36 inch recommended height and does not have a storm collar, recommend assessment and repair by a qualified HVAC contractor

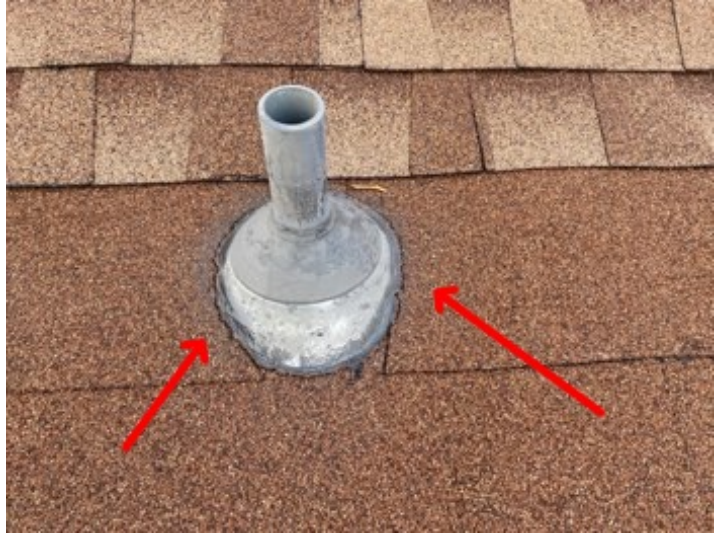
Caulking recommended to locations inch and a half vent pipe

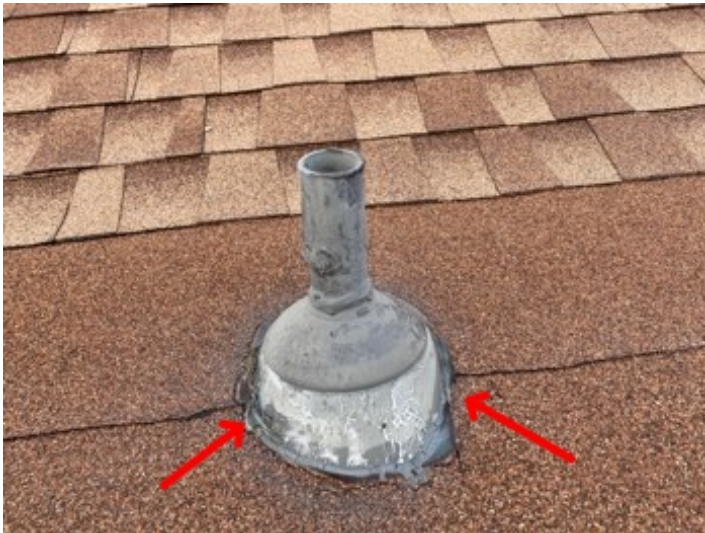
Caulking recommended

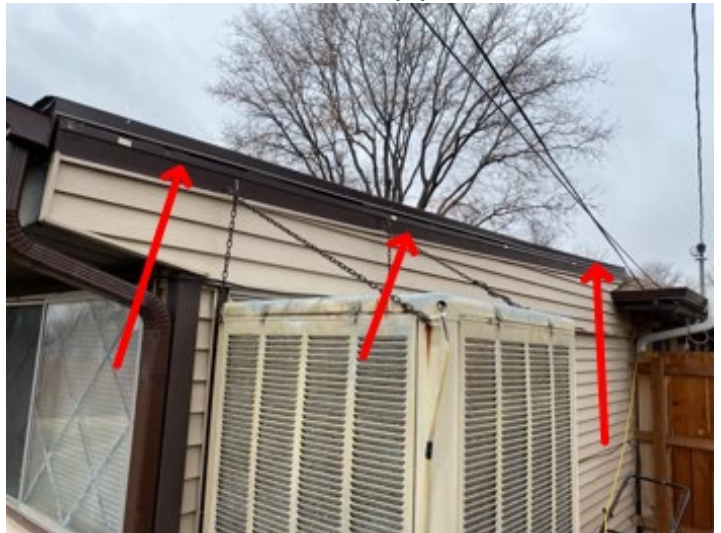
- Flashing is missing

Missing flashing noted water can enter wall covering behind siding recommend repairs by qualified contractor

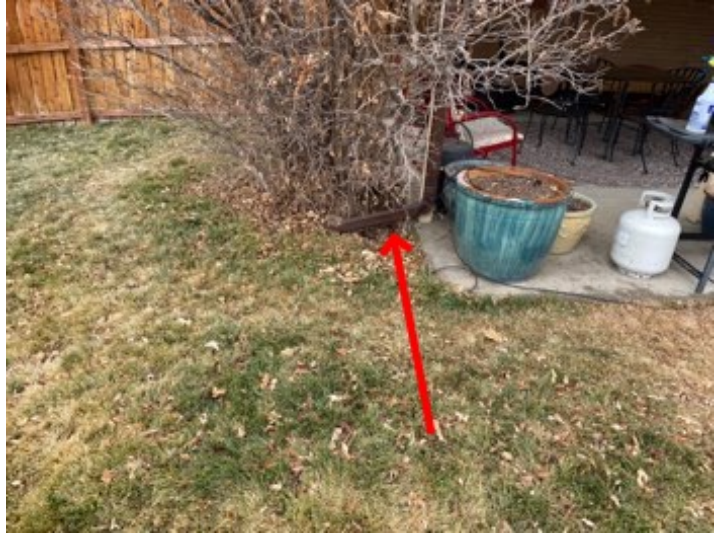
- Downspout extensions should terminate at least 6' from the foundation

Recommend downspout extension to 6 feet from the patio

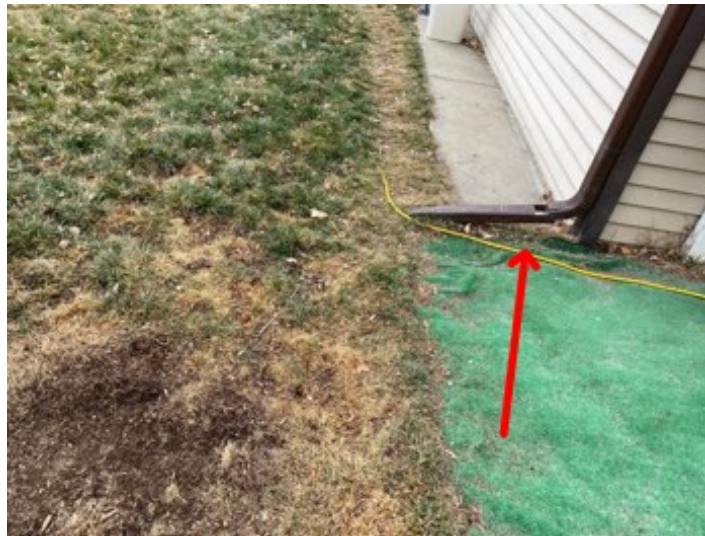
Add 6 foot extension

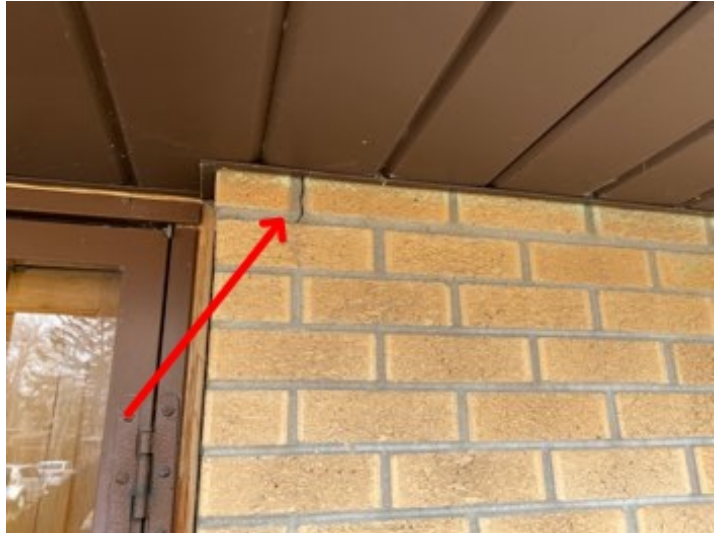
Recommend grout or sealant

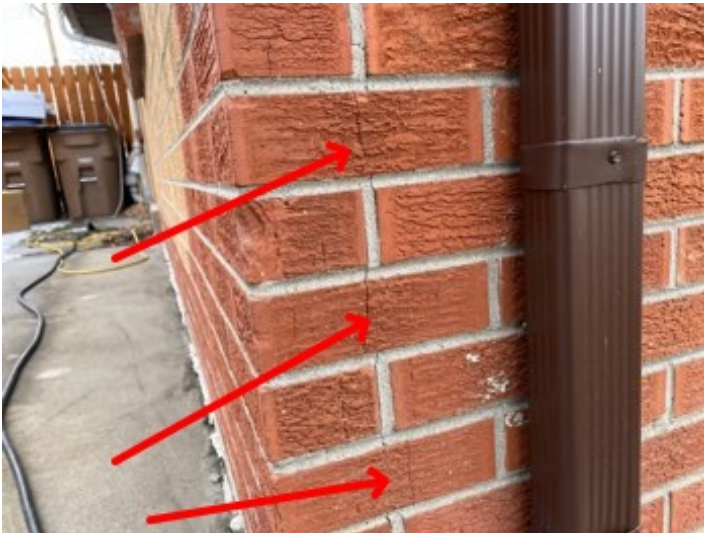
Minor cracking present in the brick recommend monitoring

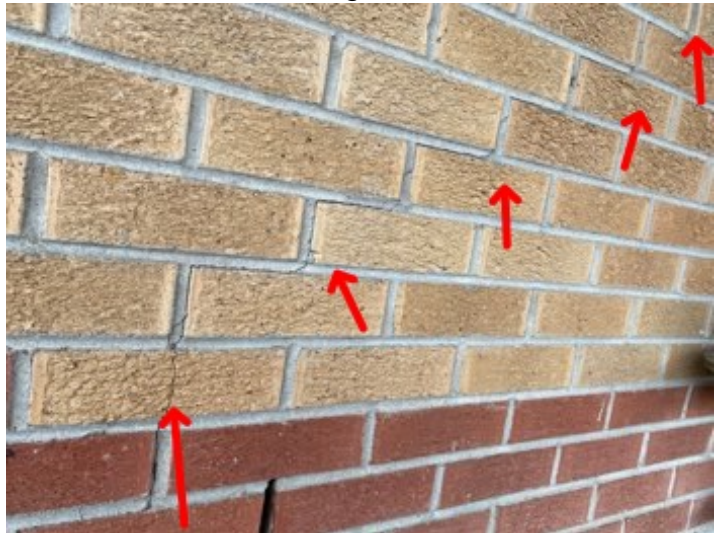
Cracking and settlement noted recommend monitoring

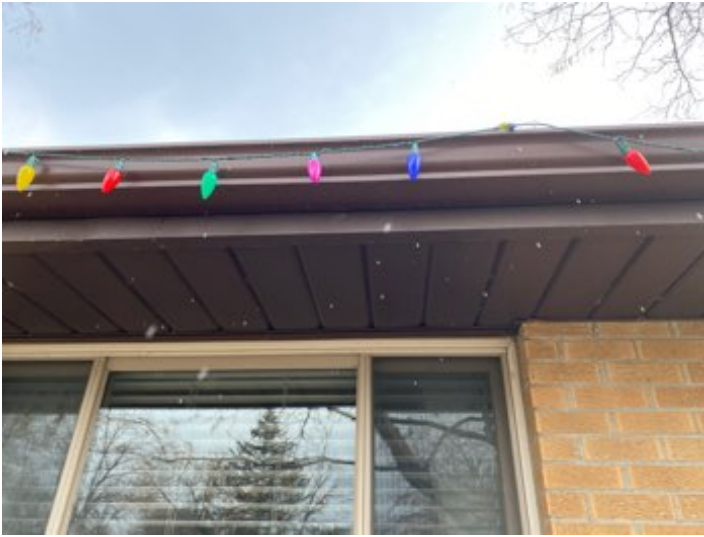
Recommend caulking and painting

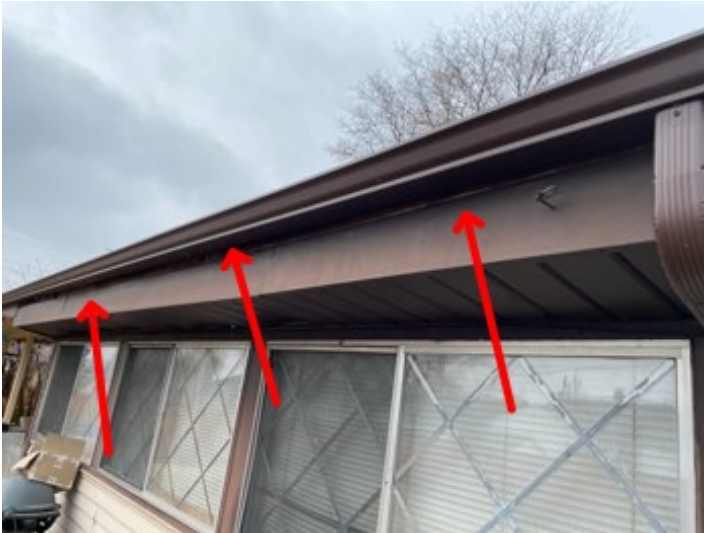
Exposed wood noted recommend extending fascia to up behind gutter to protect exposed wood, assessment and repair by qualified contractor

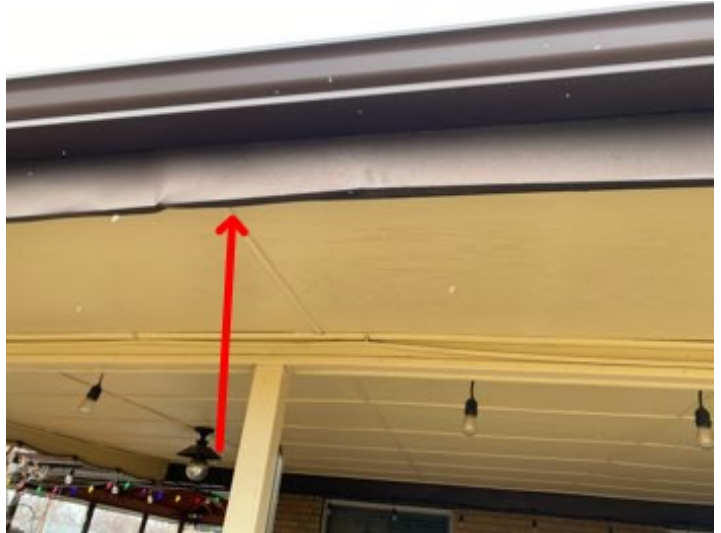
Damaged fascia noted recommend replacement by qualified contractor

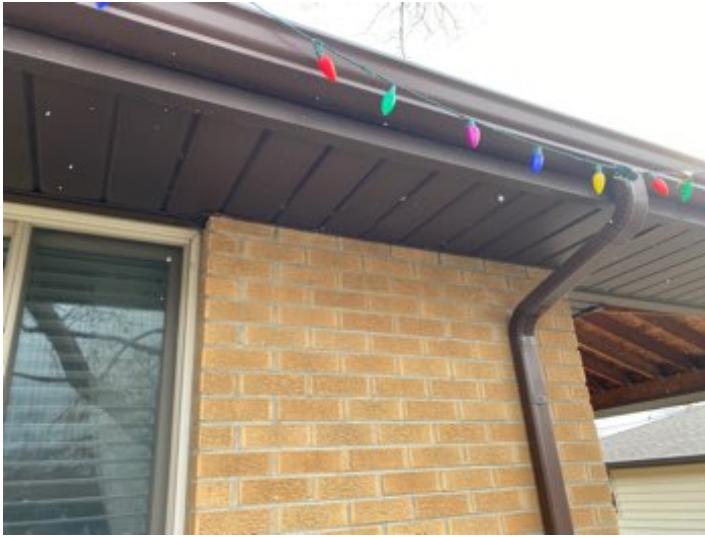
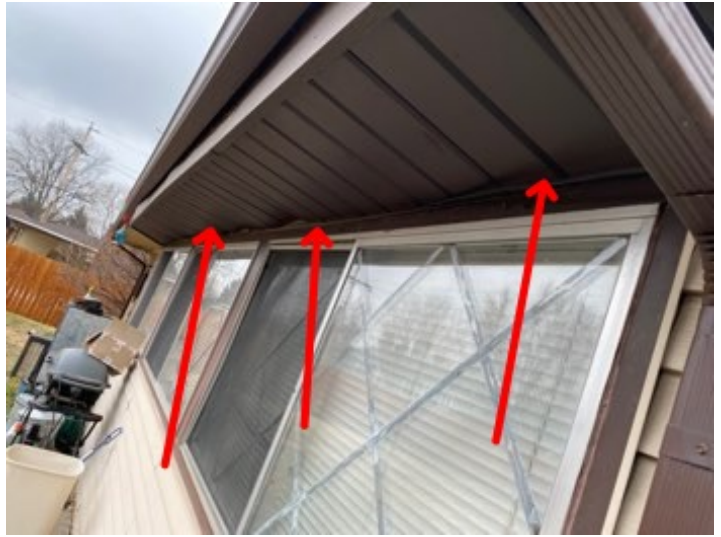
Damage soffits noted recommend repairs by qualified contractor

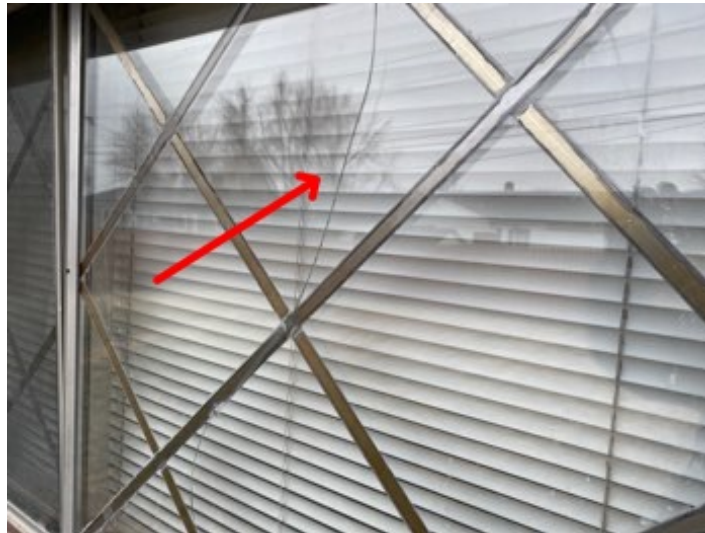
Broken glass noted recommend replacement by qualified contractor

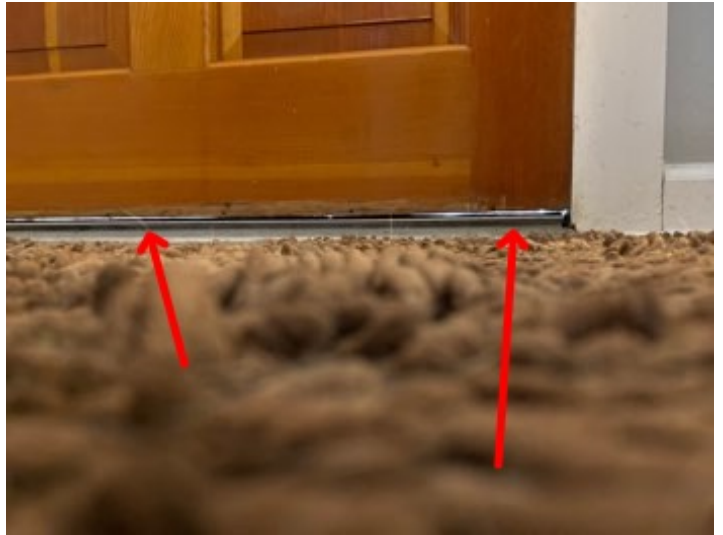
Daylight visible at door bottom, Recommend repairs by qualified contractor

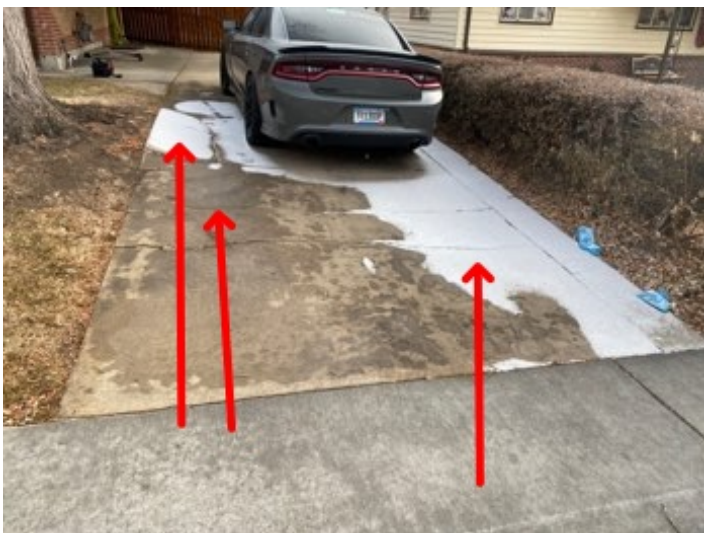
Cracking and heaving noted

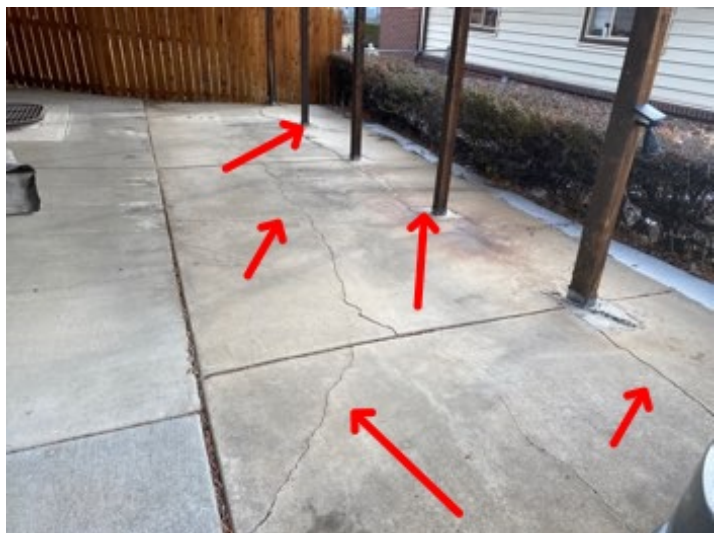
Cracking noted recommend Caulking and monitoring

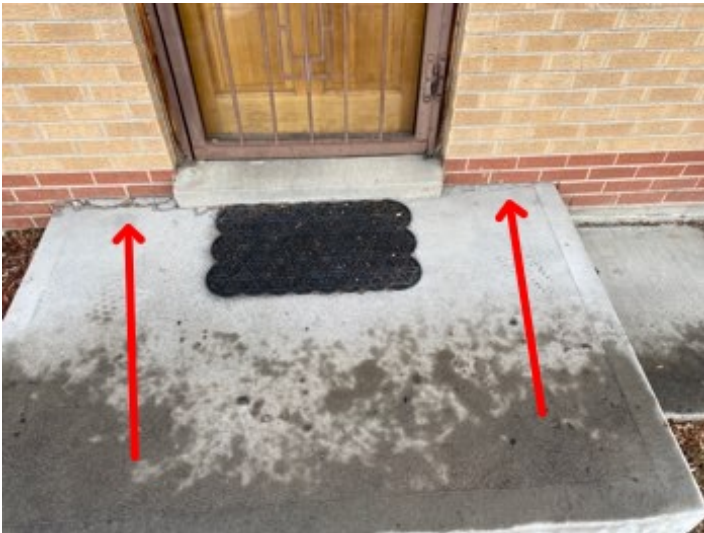
Settlement noted recommend caulking and monitoring for additional settlement

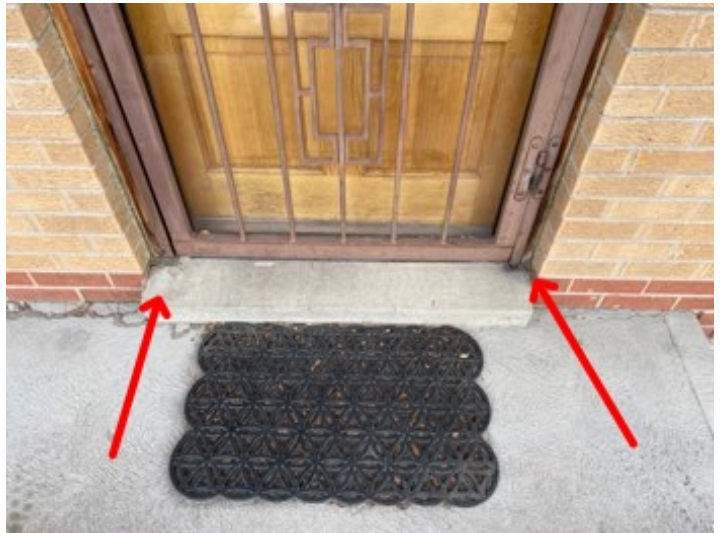
Caulking recommended

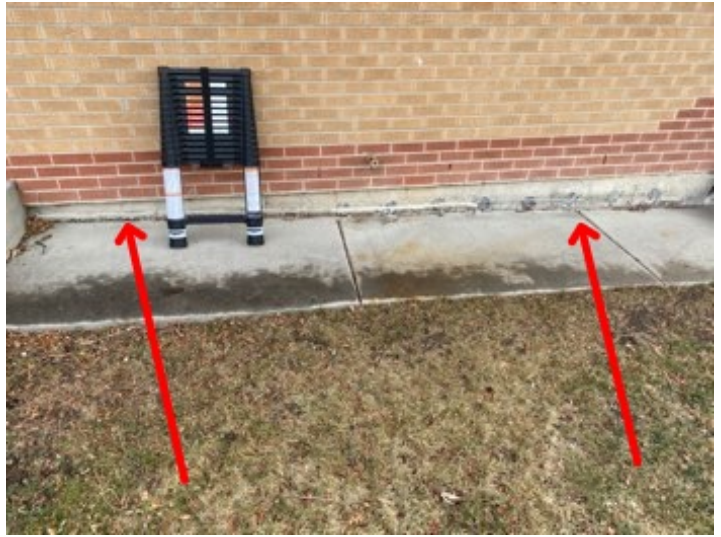
Settlement noted recommend re-caulking to prevent water infiltration

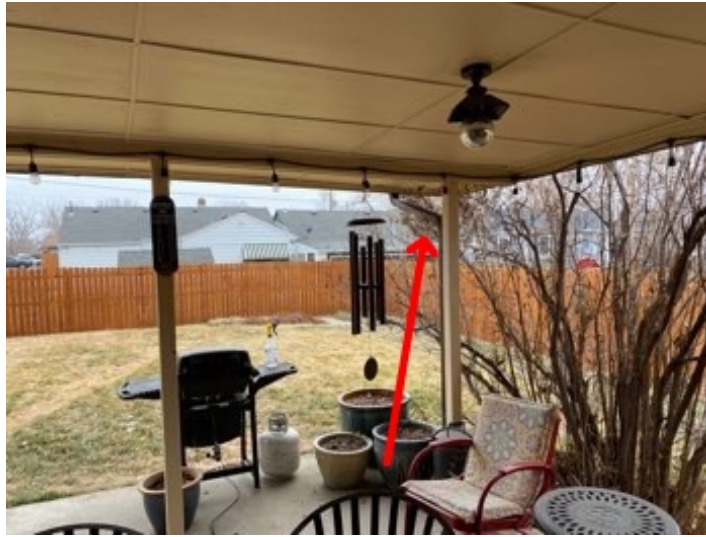
Significant settlement noted recommend monitoring

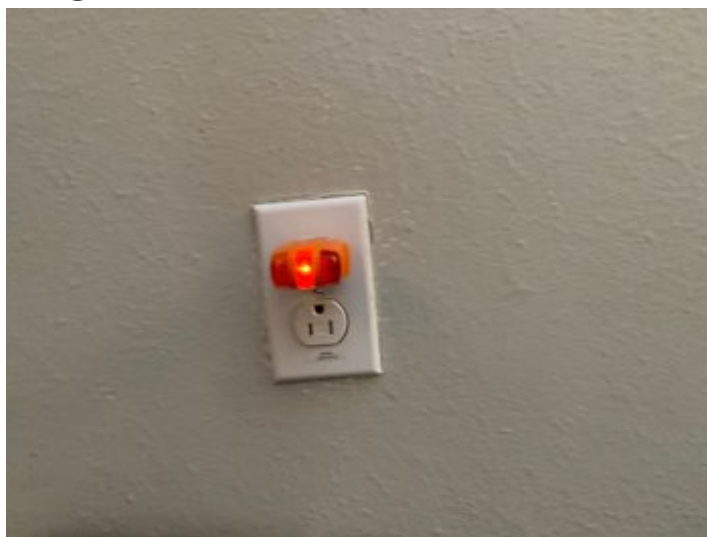
Un-grounded not GFCI protected outlet noted

- The inspector recommends evaluation by a licensed electrician. While most outlets in the home are grounded or equipped with a **GFCI**, some outlets have neither and should be addressed by an electrician.

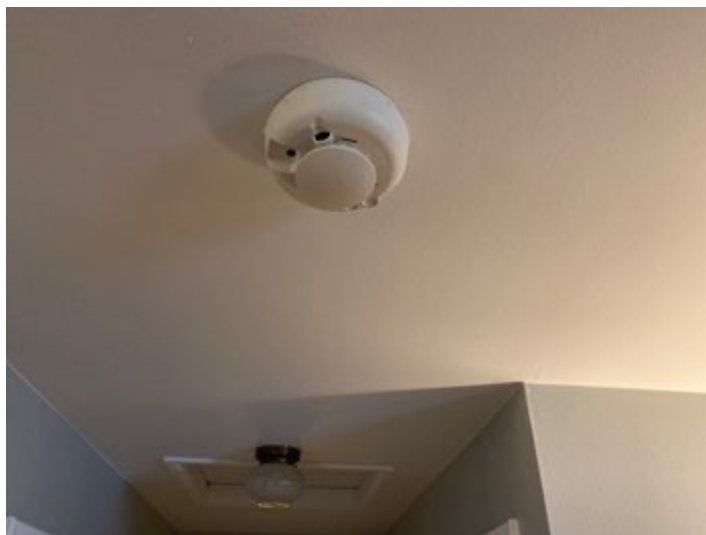
- Recommend adding carbon monoxide detectors on each level
- Colorado law requires carbon monoxide detectors within 15 feet of bedrooms

The inspector was not able to identify as CO2 detector, recommended identification or installation of new CO2 detector

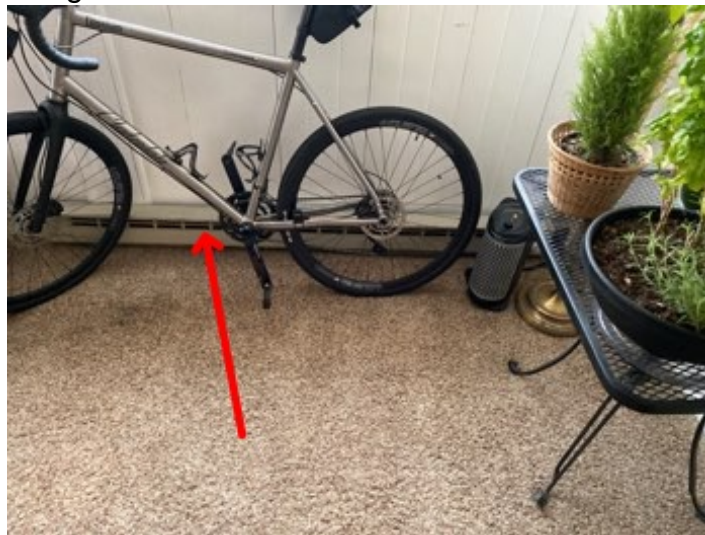
Baseboard heaters were not tested for this inspection. Recommend assessment by a qualified contractor

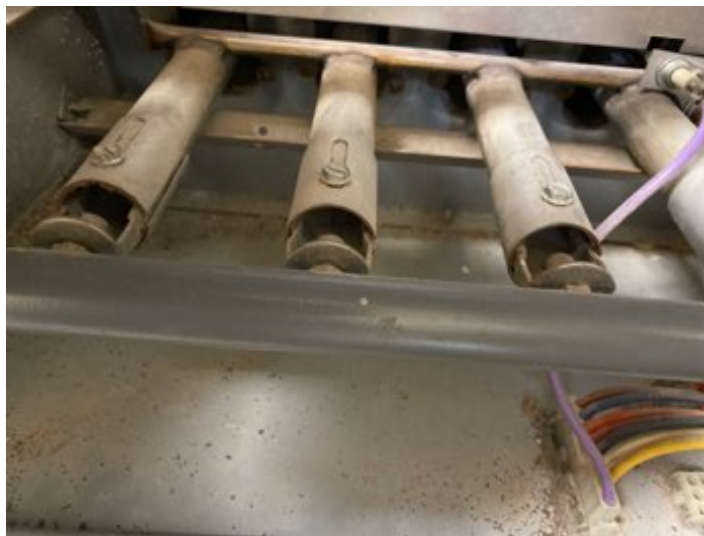
- Burners are dirty

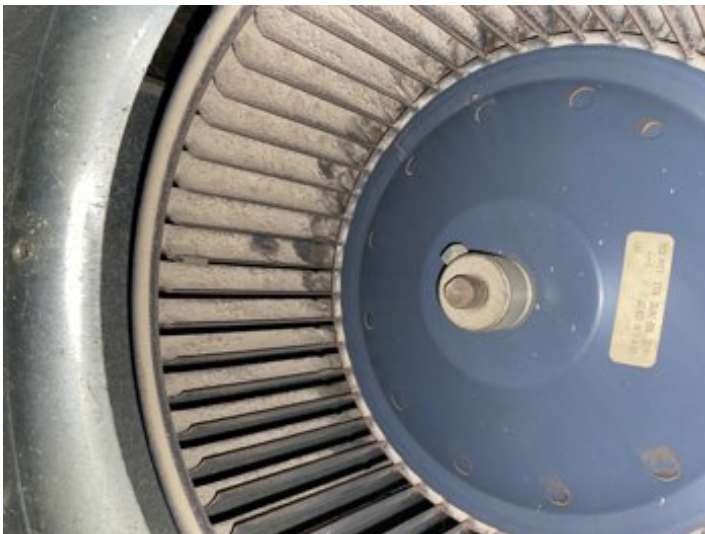
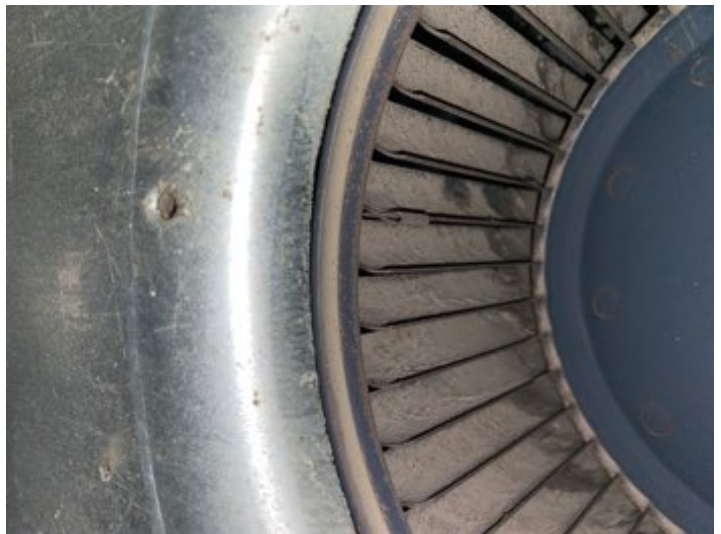
- Blower motor was dirty, recommend cleaning by a qualified contractor

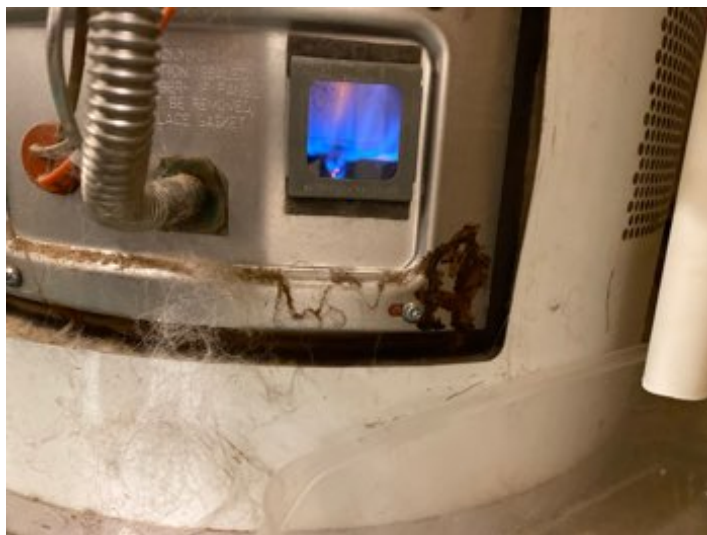
No gas leak detected

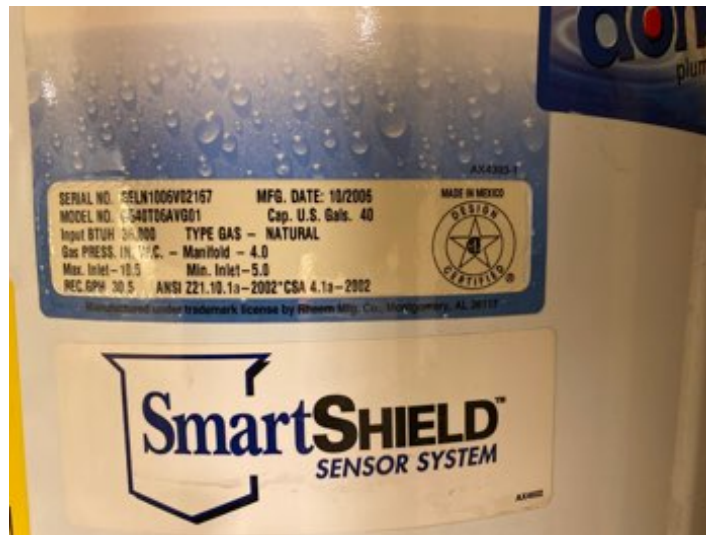
Unit is 14 years old and at the end of it's life, recommend budgeting for a new water heater

- The unit appears to be near the end of its useful life

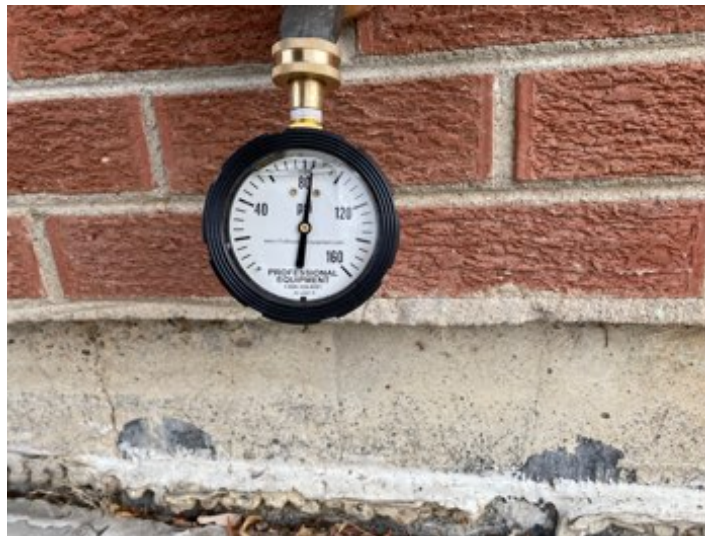
- * Excessively high water pressure - Home water supply pressure exceeded the 80 pounds per square inch (PSI) limit considered the maximum allowable by generally-accepted current standards. Excessively high water pressure is likely to cause leaks. The Inspector recommends service by a qualified plumbing contractor

- The inspector recommends assessment and repairs of the high water pressure and galvanize water supply lines by a licensed qualified plumber.

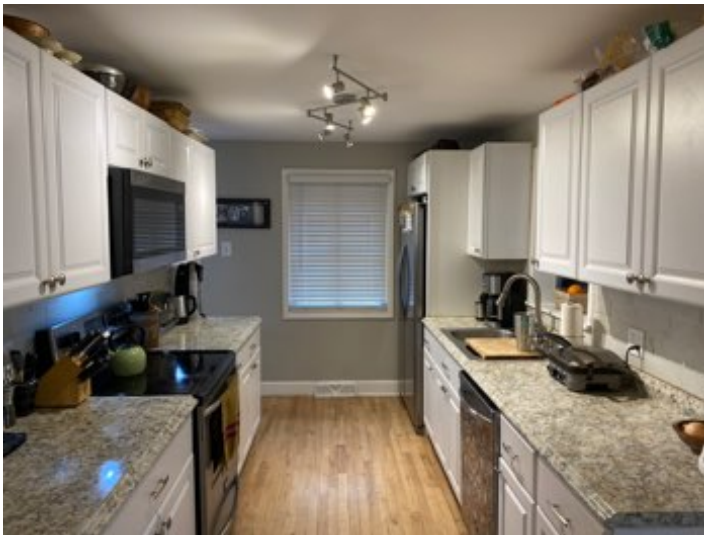
Loose hinges noted

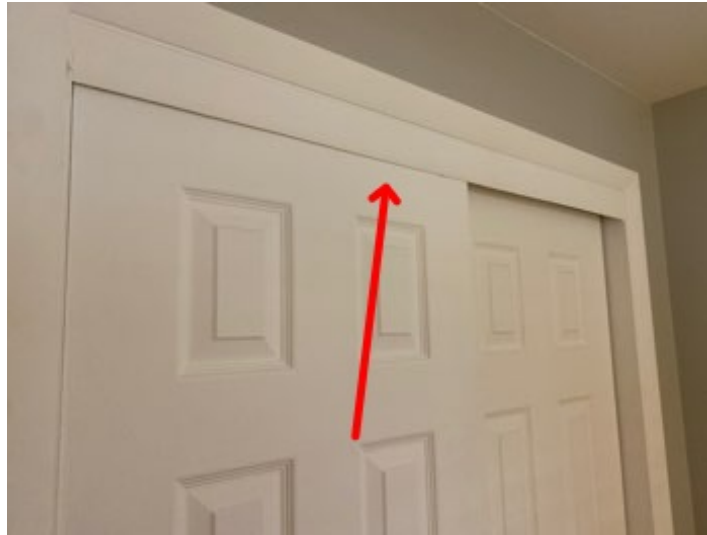
Door was observed to be in contact with the trim and difficult to operate. Recommend assessment and repairs by qualified contractor

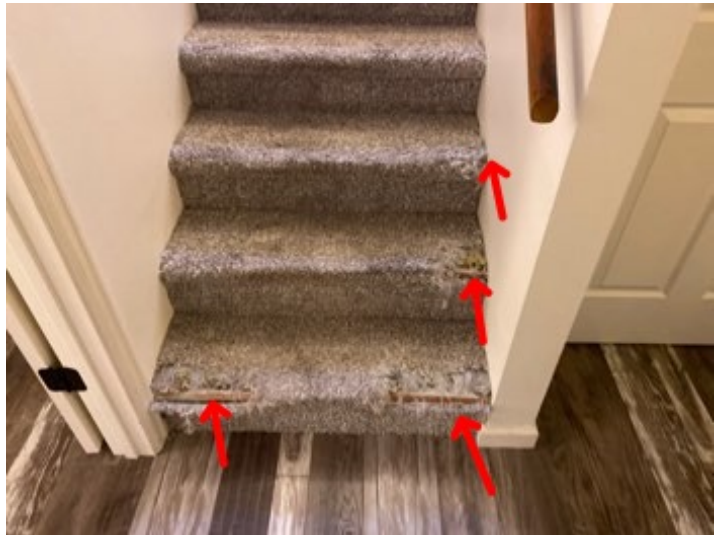
Damaged carpet noted

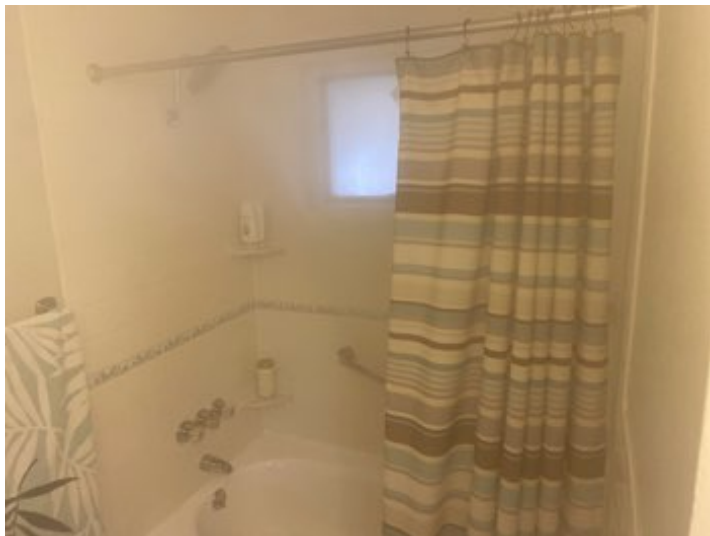
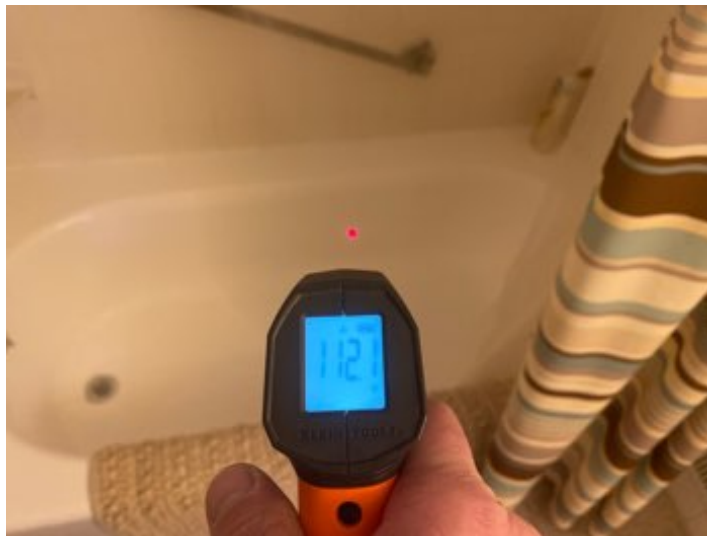
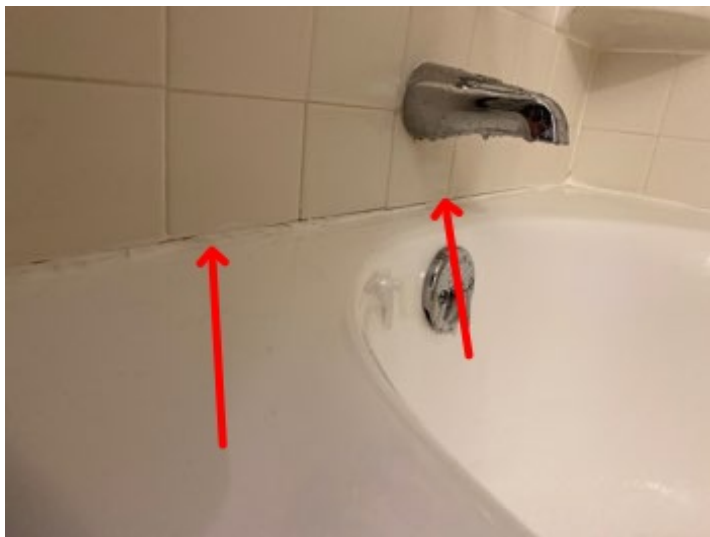
- Caulking around tub recommended

Recommend caulking

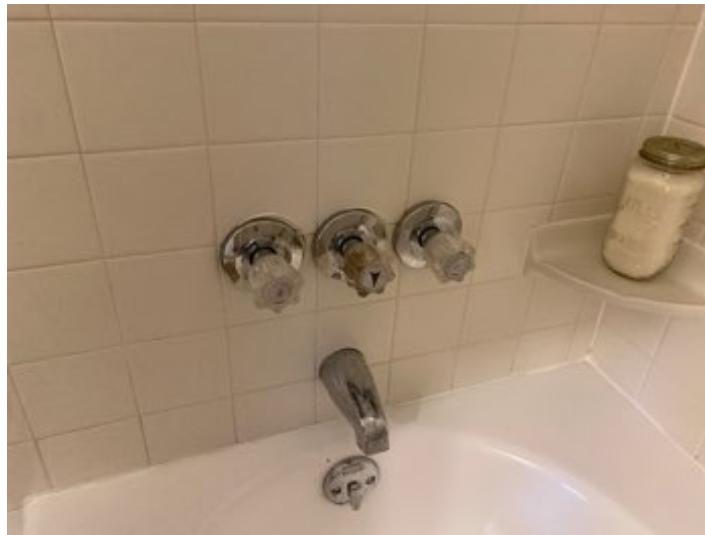
Shower plumbing is loose is wall

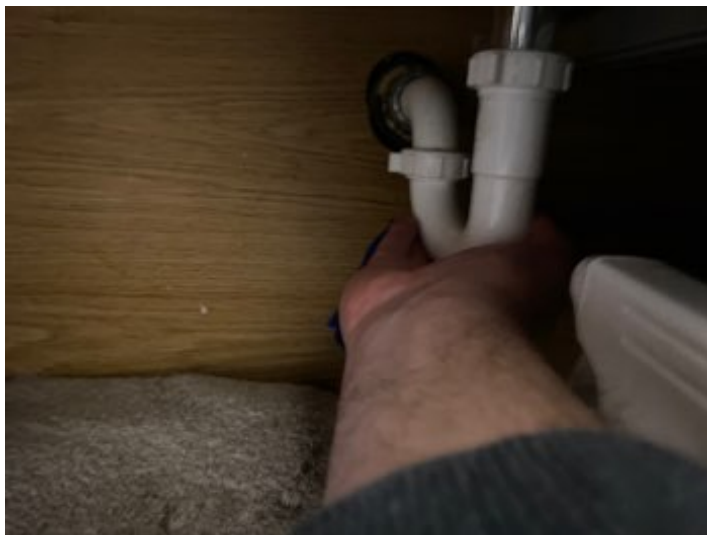
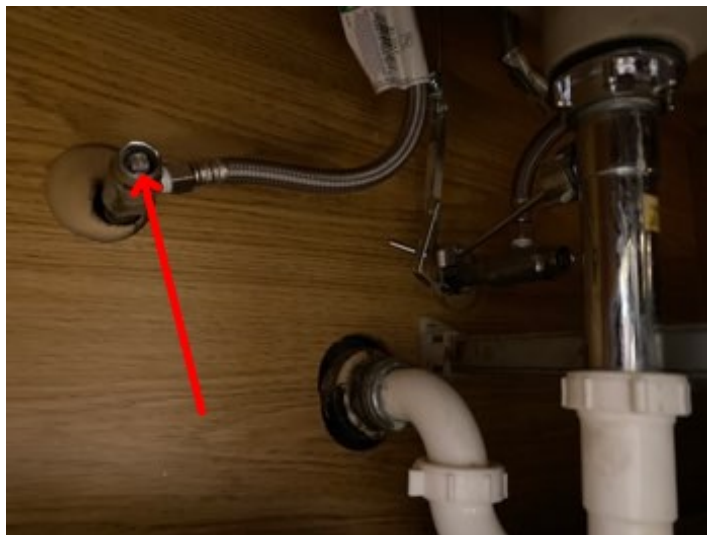
Shut off valves missing handles, recommended assessment and repairs by qualified contractor

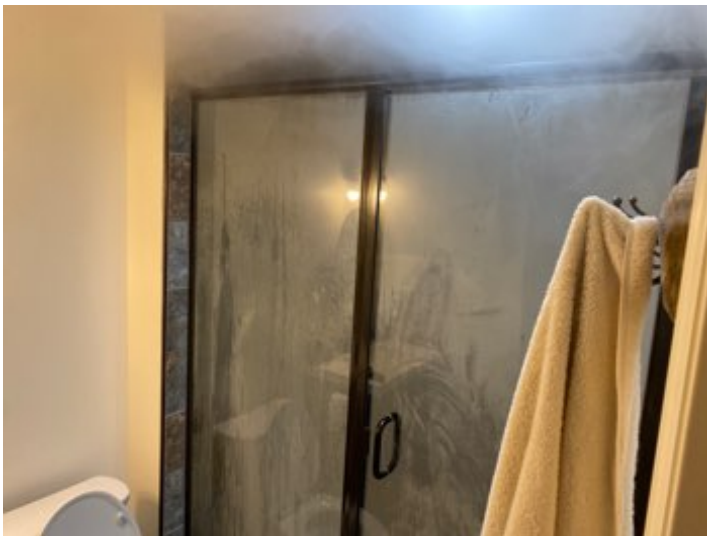
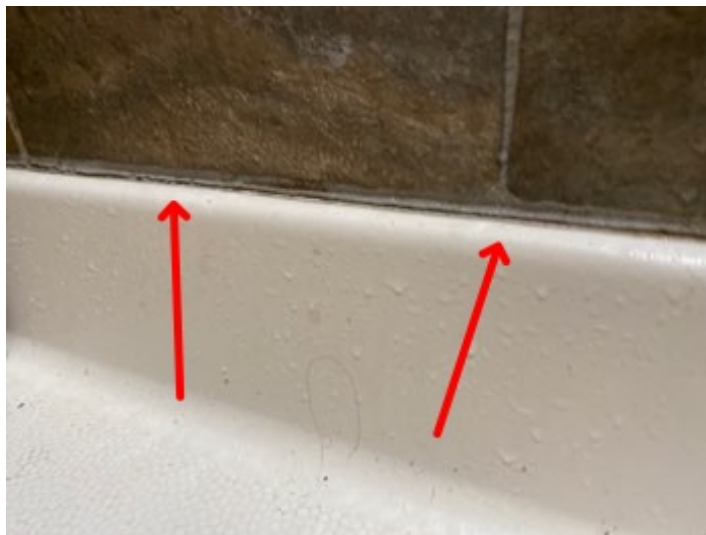
- Caulk and/or grout repair recommended

Recommend caulking

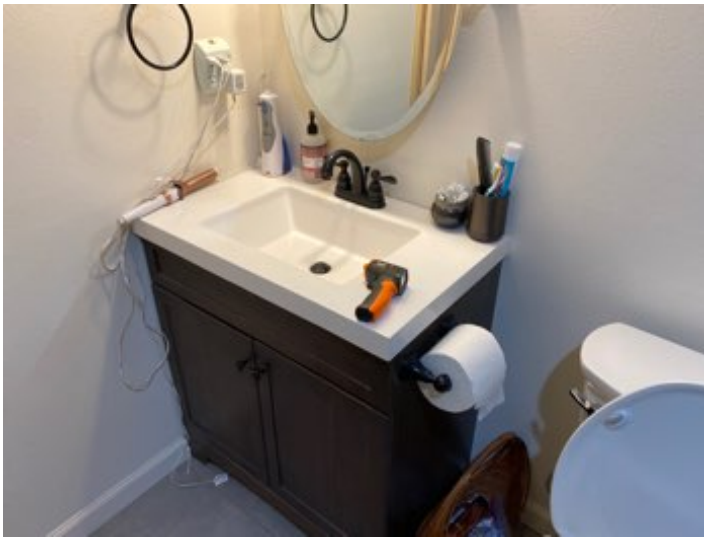
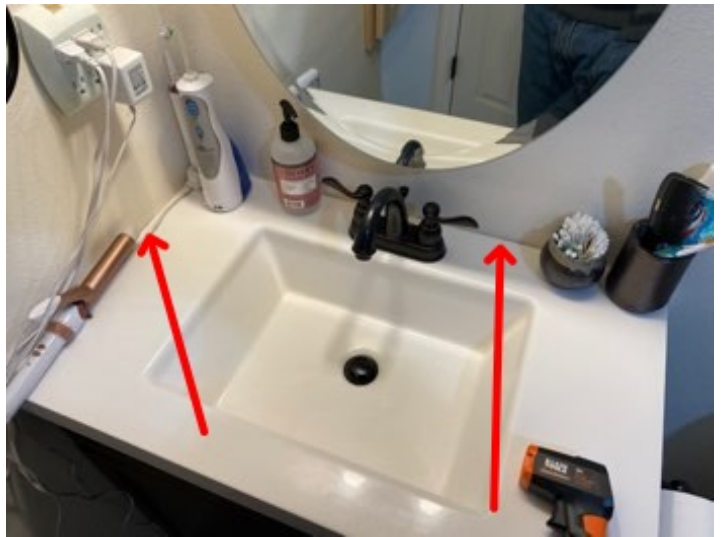
- Backsplash needs caulking

Caulking recommended
