Sunnyside Home Inspections

Property Inspection Report

123 Example St, Denver, CO 80212
Inspection prepared for: Client Example
Date of Inspection: 1/9/2021

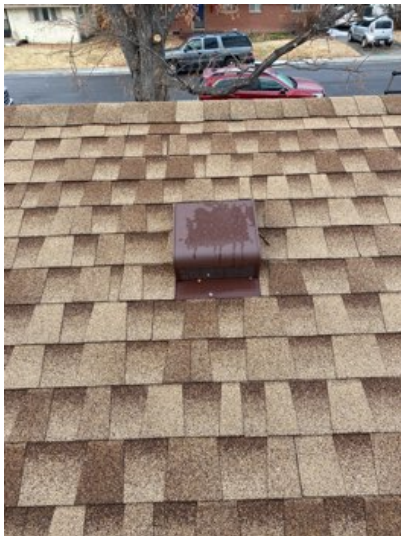
- Flue stack was too low
- Storm collar not installed
- **Caulk/Sealant is recommended**

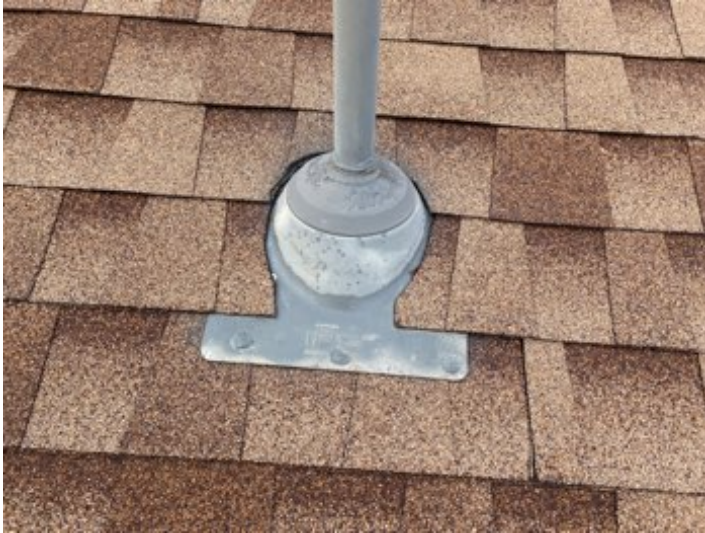
- Flashing is missing

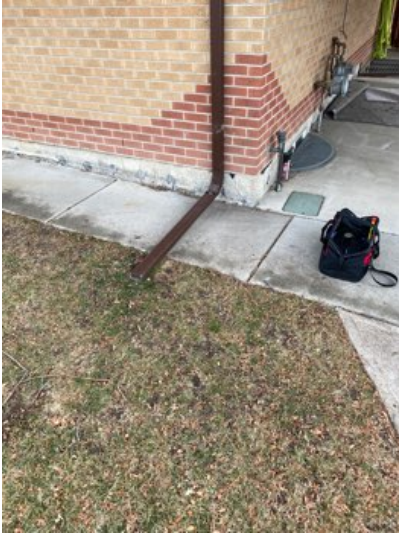
- Downspout extensions should terminate at least 6' from the foundation

Recommend downspout extension to 6 feet from the patio

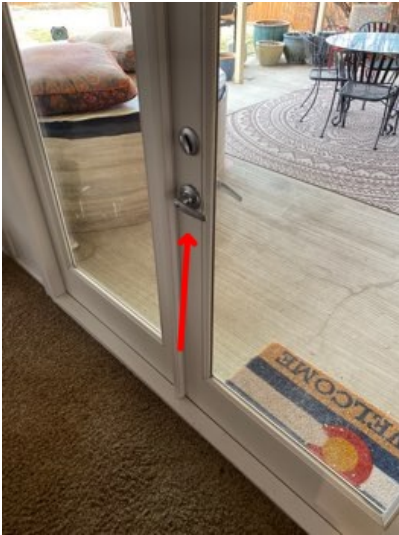
- Front door does not open easily

Door did not latch, recommend repairs by a qualified contractor

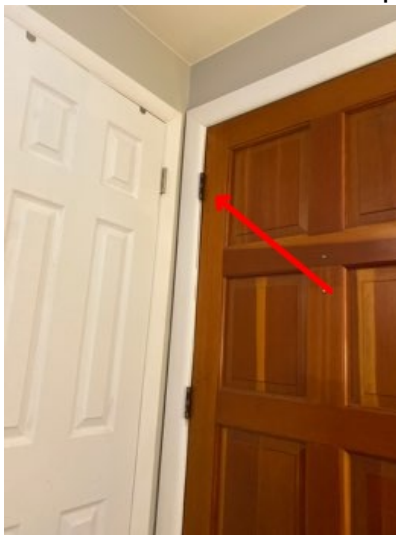
Loose hinge noted

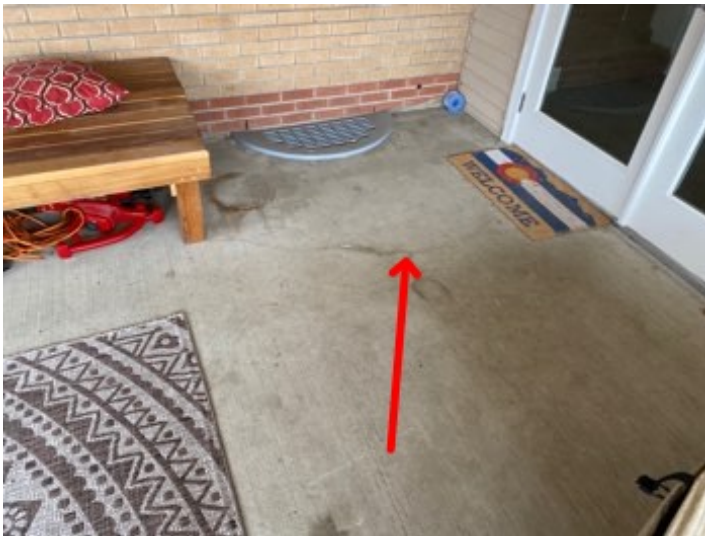
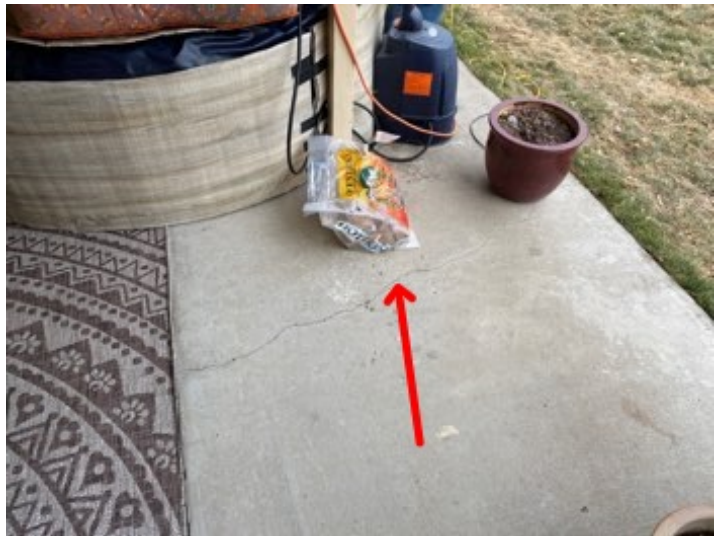
- Settlement noted
- Cracking noted, monitor and caulk as necessary

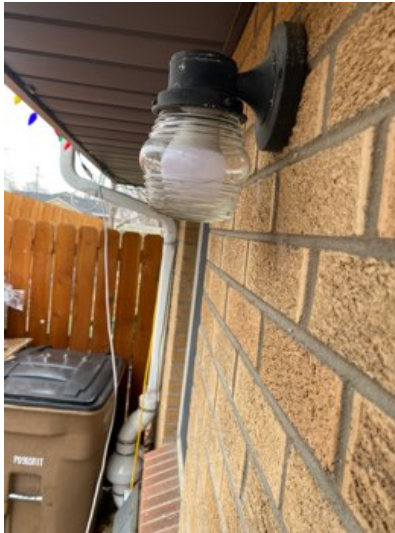
Light did not respond to switch, check bulb

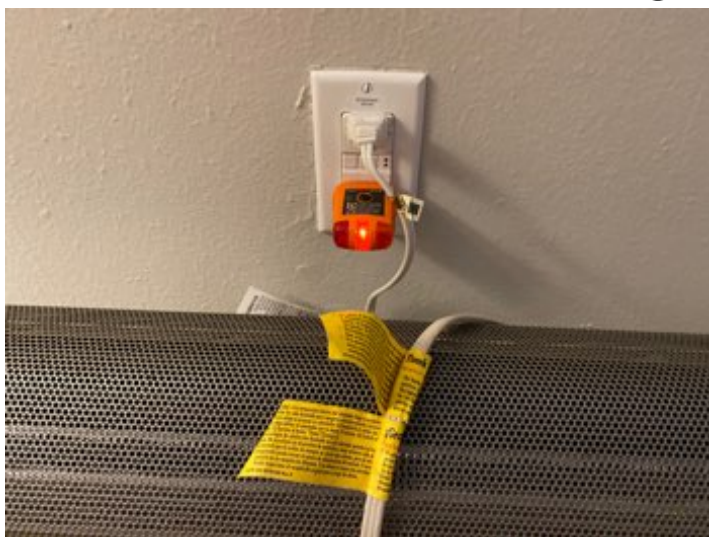
- Ungrounded outlets were present in the home

Example of un-grounded GFCI protected outlet

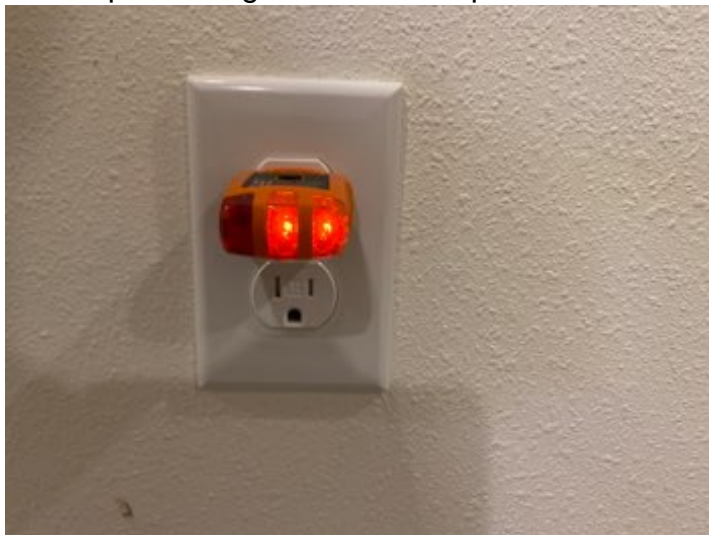
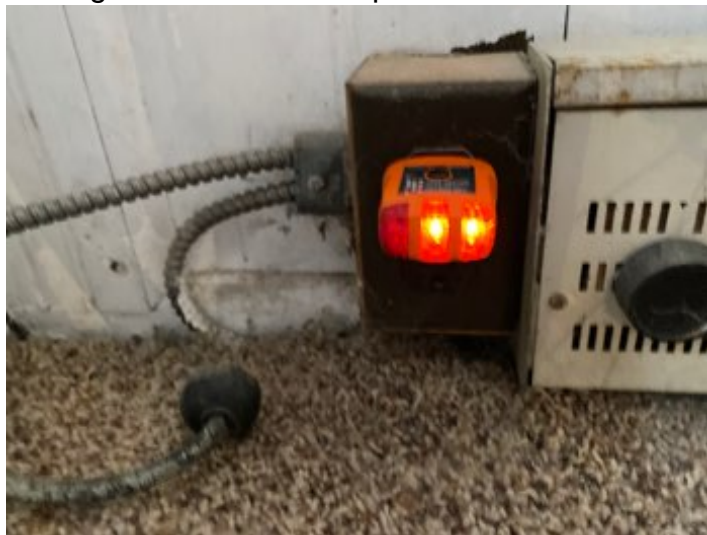
Un-grounded not GFCI protected outlet noted

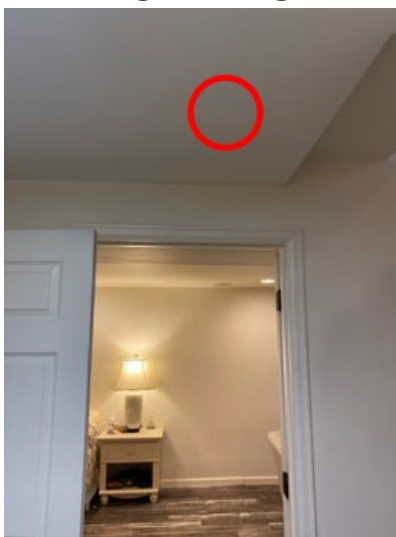
- The inspector recommends installing additional smoke detectors

Smoke and CO2 detector recommended here

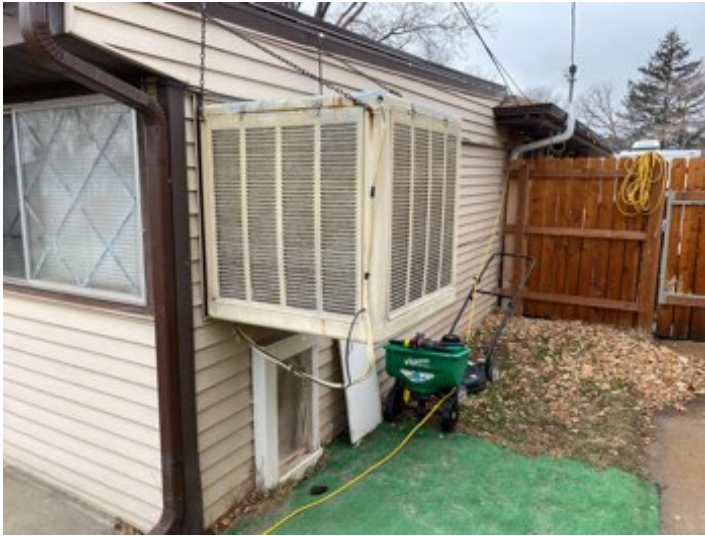
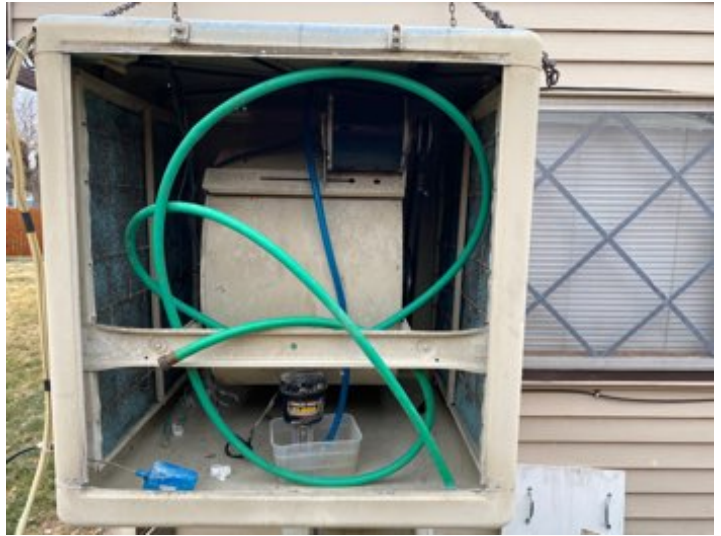
- Rust present
- Not tested

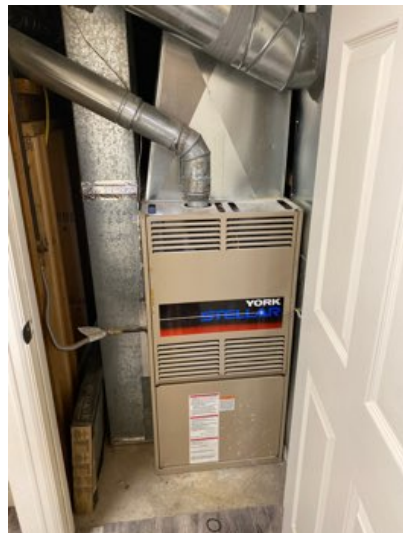
No gas leak detected

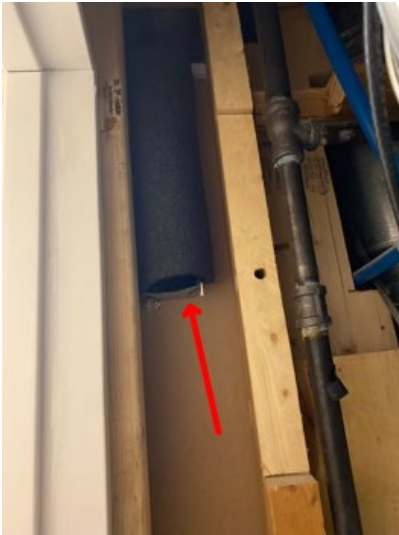
Combustion air covered by pipe insulation
recommend removing insulation

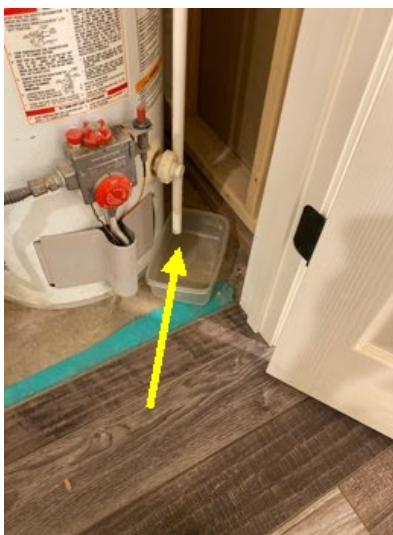
Potential evidence of leaky TPR valve recommend assessment and repair by qualified contractor

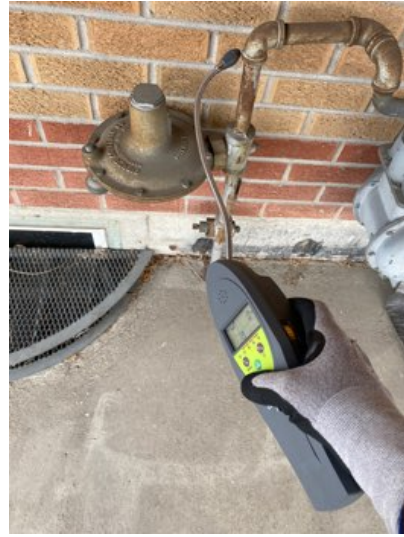
Gas leak detector, No leak found

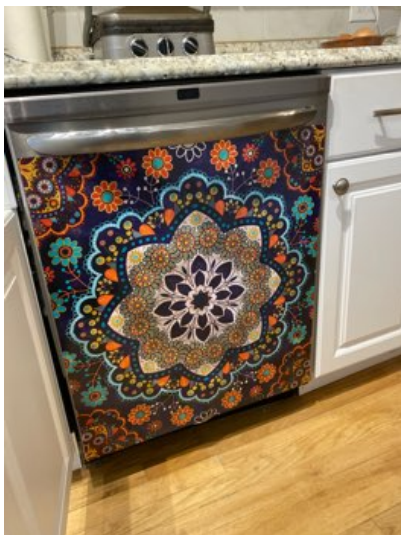
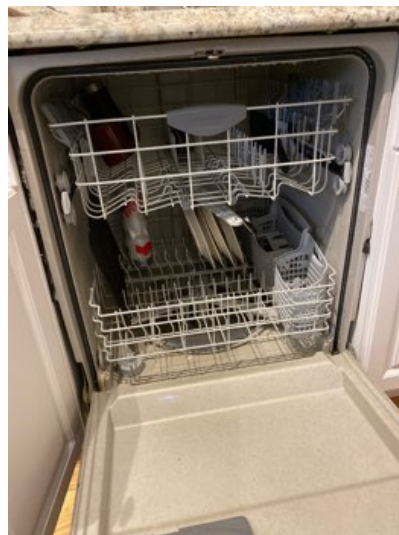
- Dishwasher was not tested by inspector. In use by homeowner
- High loop/**air gap** not installed

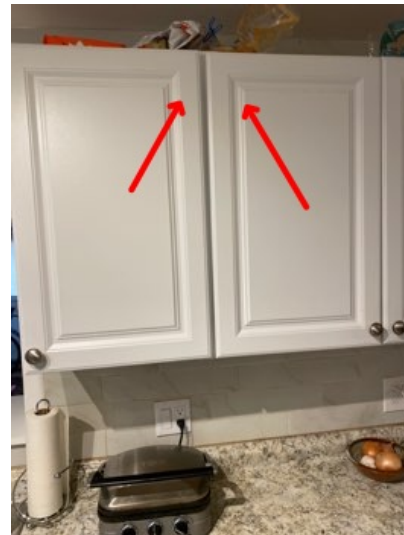
Loose hinges noted

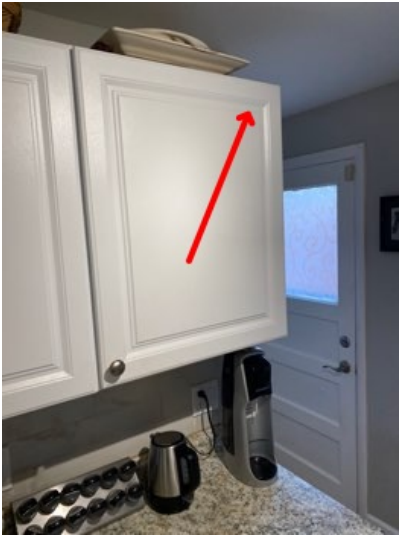
Loose hinge noted

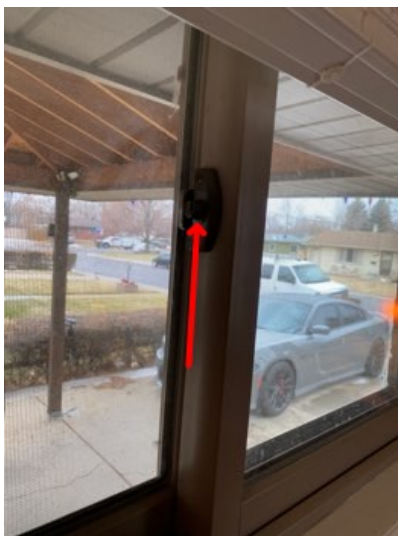
- Lock does not operate properly

Broken latch noted

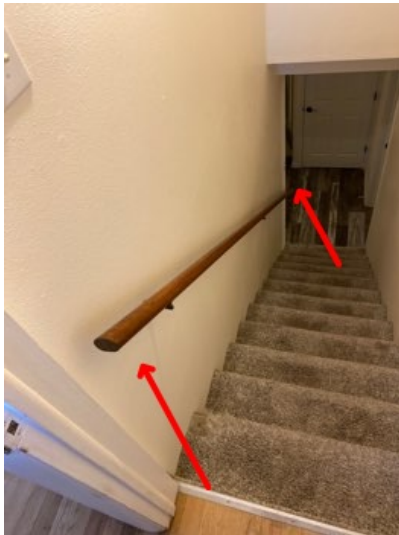
- Handrail does not return to the wall. A handrail must return to the wall or terminate at a newel post. This is to prevent personal items from catching on the end of the railing, which could cause a fall.

No returns noted

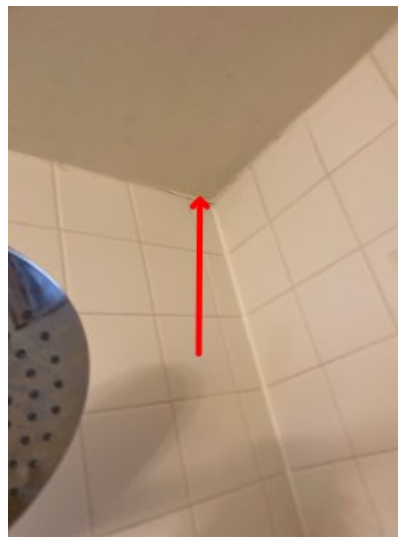
- Caulking around tub recommended

Recommend caulking

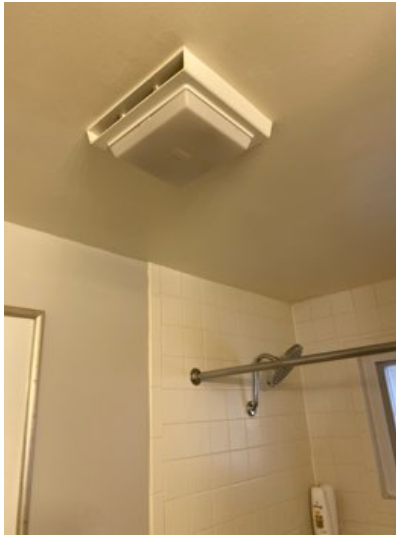
Light did not function, check bulb

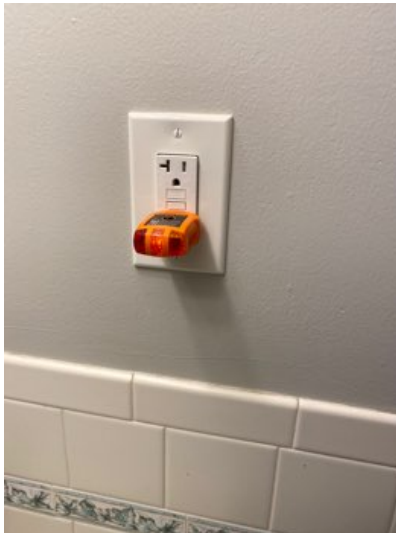
- **GFCI** does not trip

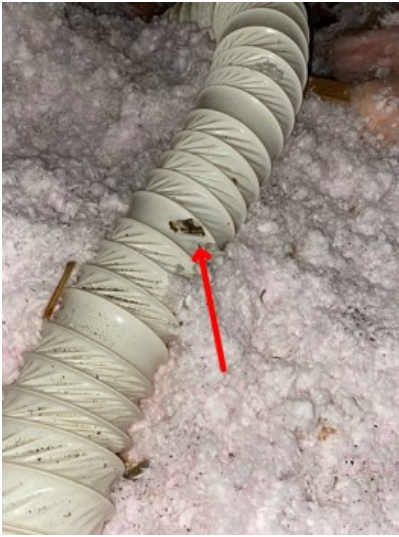
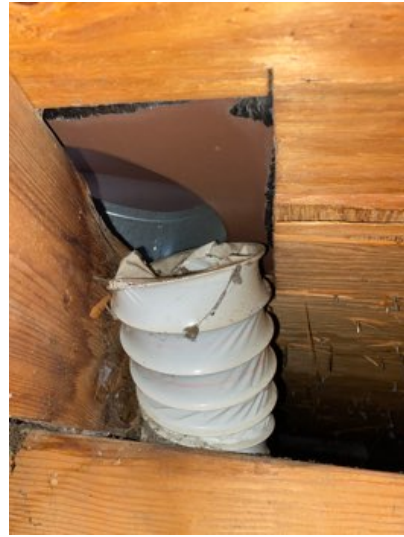
Dryer duct was observed being used for bathroom exhaust duct and it had a hole in it, recommended assessment and repairs by a qualified contractor

Bath fan duct was observed ducting into the attic by a roof vent, recommended ducting to its own sealed roof termination by a qualified contractor

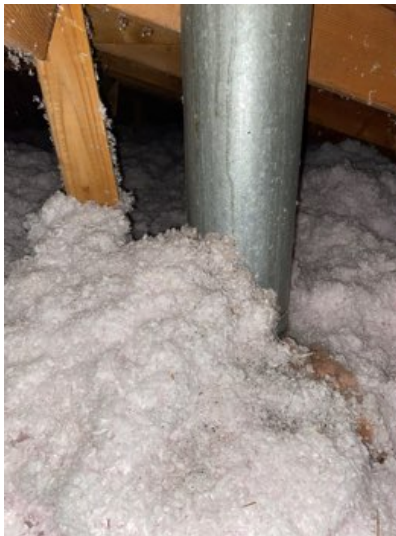
Furnace flue does not have minimum 1inch clearance from combustibles, recommended repairs by a qualified contractor
